STRUCTURAL TECHNIQUES FOR JOINING FILAMENTARY COMPOSITES

G. A. CLARK and K. I. CLAYTON North American Rockwell Corporation Columbus, Ohio

AIAA Paper No. 68-1038 19960411 018

AIAA 5th Annual Meeting and Technical Display

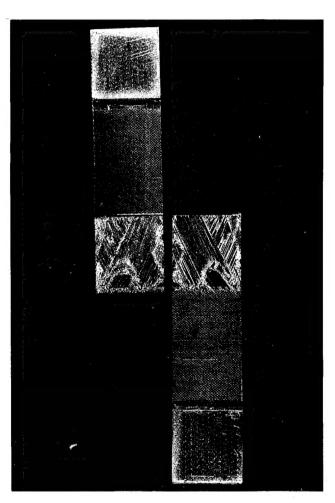
FIGURE 2. BONDED LAP JOINT-TYPICAL INTERLAMINAR SHEAR FAILURE

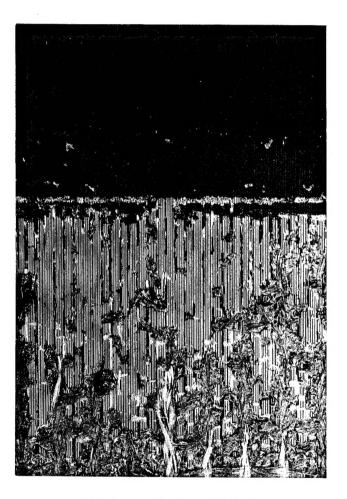
oriented boron layer is placed on the surface next to the bond line. Failure of the adhesive bond was initiated where the laminating resin was separated from the boron filament as shown in Figure 3. Double lap shear test results on metal adherends confirmed that the low modulus adhesive which has considerable plastic behavior, is far superior at room temperature to the high modulus adhesive but only slightly better than the marriage of the two. This latter situation may not be true if the effects of fatigue, creep, or moderately elevated temperature are considered. Test data of multidirectional boron laminates infers that the structural potential of an adhesive bond cannot be fully utilized until the interlaminar shear and/or laminating resin to boron filament integrity is improved.

FIGURE 3. DETAIL OF SURFACE FAILURE-LAP SHEAR SPECIMEN

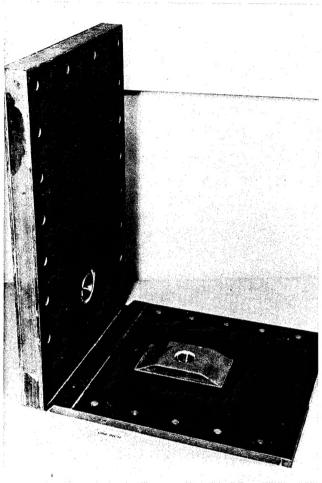
A static test was conducted to verify the structural integrity and fabrication quality of the advanced concept demonstration article. Run No. 1 was conducted to 98% design limit load (D.L.L.) at which time a cracking sound was heard and the load dumped. After 60% D.L.L. of Run No. 2, a chamfer, approximately .060 x 45°, was cut on the corner of the joint at the intersection of the spar and skin panels to eliminate interference between the specimen and loading jig. Run No. 3 and Run No. 4 were prematurely dumped after 100% D.L.L. and 75% D.L.L., respectively, when sounds were again heard. Run No. 5 was then conducted to failure which occurred

FIGURE 12. COMPLETED ASSEMBLY ADVANCED CONCEPT

An adhesive bond failure between the glass insert housing the spherical bearing and the glass doubler which reinforces the boron spar facings was the primary cause of failure. The non-linearity of dial gages and axial strain gages located in the area of the spar spherical bearing insert showed the yielding of the failed bond from 80%-100% D.L.L. to failure at 160% D.L.L. The spar panel was disassembled after failure revealing a poor bond over the area inside the attaching doublers and to some degree over the doublers themselves. The poor bond was apparently caused by excessive use of the foaming type HT424D for a shear tie between the core and inserts. This can be eliminated by (1) using a non-foaming type shear tie or (2) by assembly of the core-insert blanket then bonding to the skindoubler facings.

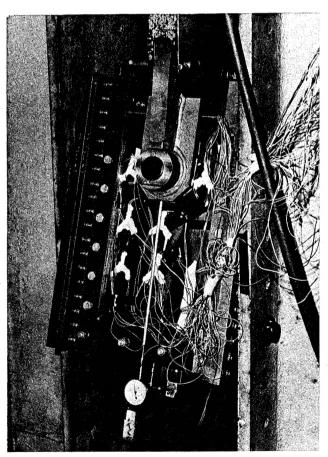
FIGURE 13. TEST FIXTURE-ADVANCED CONCEPT, ITEM #2

An adhesive bond failure between the glass insert housing the spherical bearing and the doubler which reinforces the boron spar facings, along with interlaminar shear failure within the glass insert itself, were the primary cause of failure leading to subsequent edgewise shear failure of the .021 boron spar facings along the previously discussed transition line, 3.85 inches from centerline. As in prior testing, the fitting to wing cover skin panel was not critical.
